The fire resistance performance of a specimen of an asymmetrical, non-loadbearing wall assembly, tested in accordance with BS 476: Part 22: 1987, Clause 5

352737

**International Petroleum Products Ltd**

24<sup>th</sup> August 2015

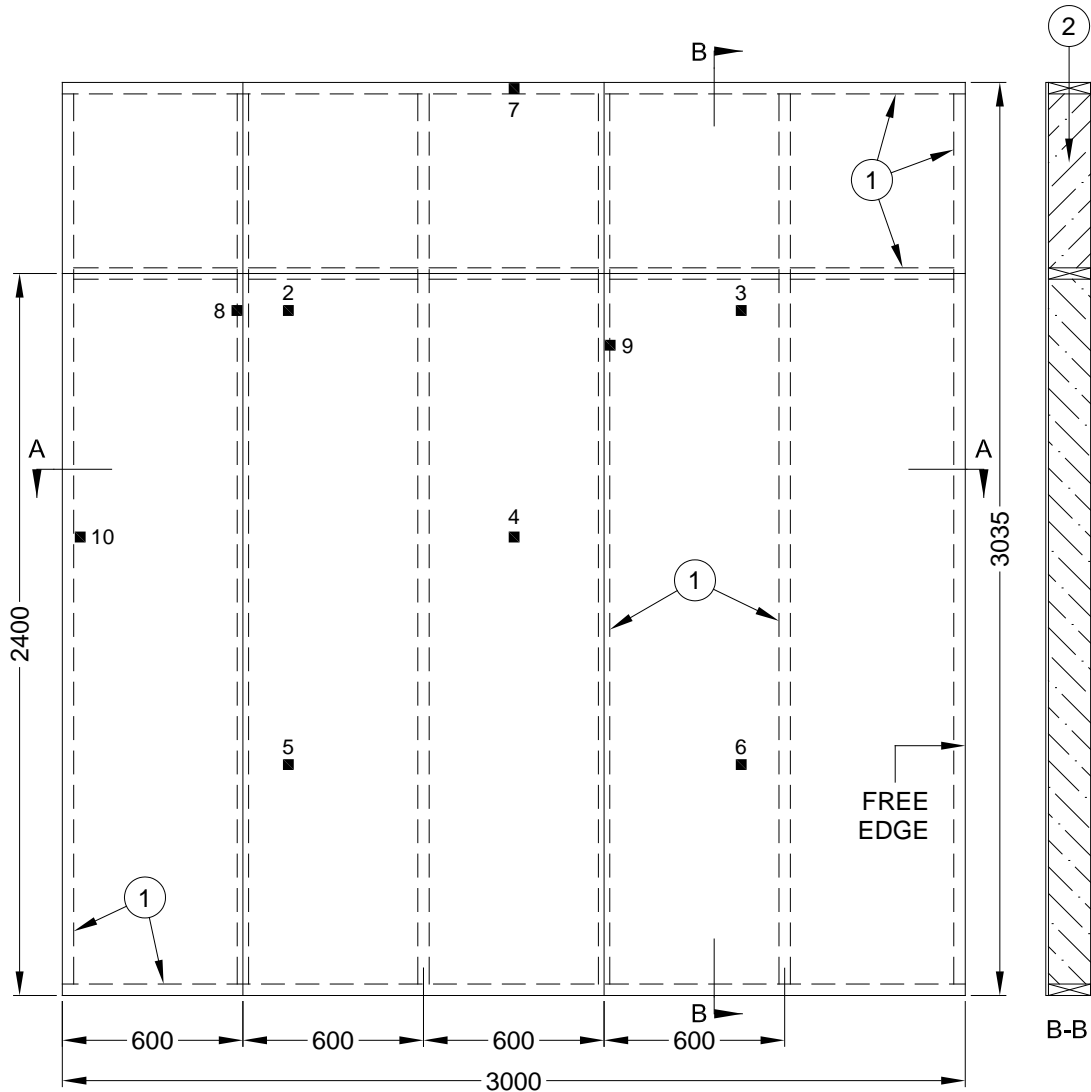
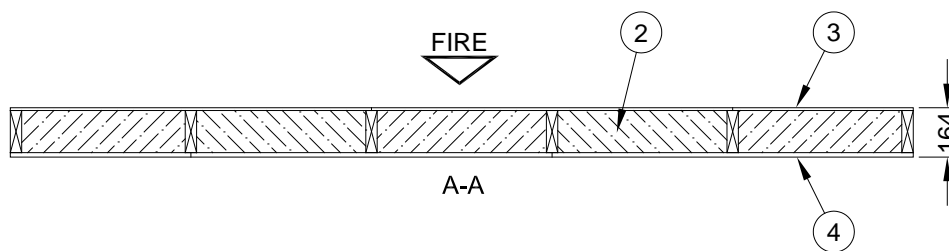
Figure 1- General elevation and details of test specimen and unexposed face thermocouples

GENERAL ELEVATION  
OF UNEXPOSED FACE

■ Positions of thermocouples

(Refer to Figure 1)  
(All values are nominal unless stated otherwise)  
(All other details are as stated by the sponsor)

<b>Thermocouple 10</b>	Positioned at mid-height, nominally 100 mm from the fixed edge.
	The locations and reference numbers of the various unexposed surface thermocouples are shown in Figure 1.
<b>Roving Thermocouple</b>	A roving thermocouple was available to measure temperatures on the unexposed surface of the specimen at any position which might appear to be hotter than the temperatures indicated by the fixed thermocouples.
<b>Integrity Criteria</b>	Cotton pads and gap gauges were available to evaluate the permeability of the specimen to hot gases.
<b>Furnace Pressure</b>	After the first five minutes of testing and for the remainder of the test, the furnace atmospheric pressure was controlled so that it complied with the requirements of BS 476: Part 20: 1987, Clause 3.2.2. The calculated pressure differential relative to the laboratory atmosphere at the top of the specimen was 17 ( $\pm 2$ ) Pa.

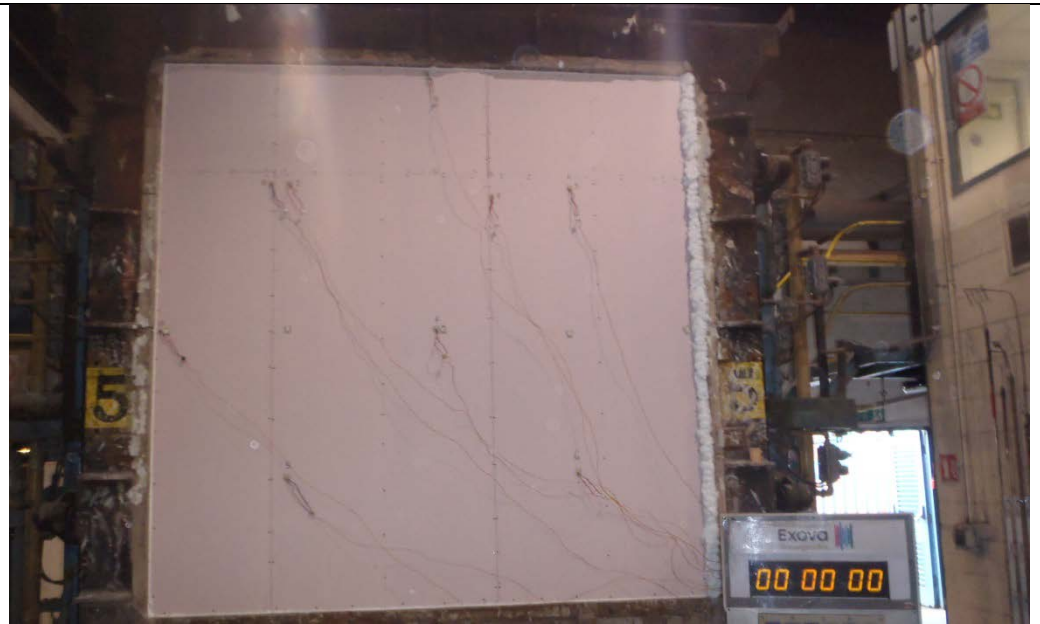
The unexposed face of the test construction as the test commences

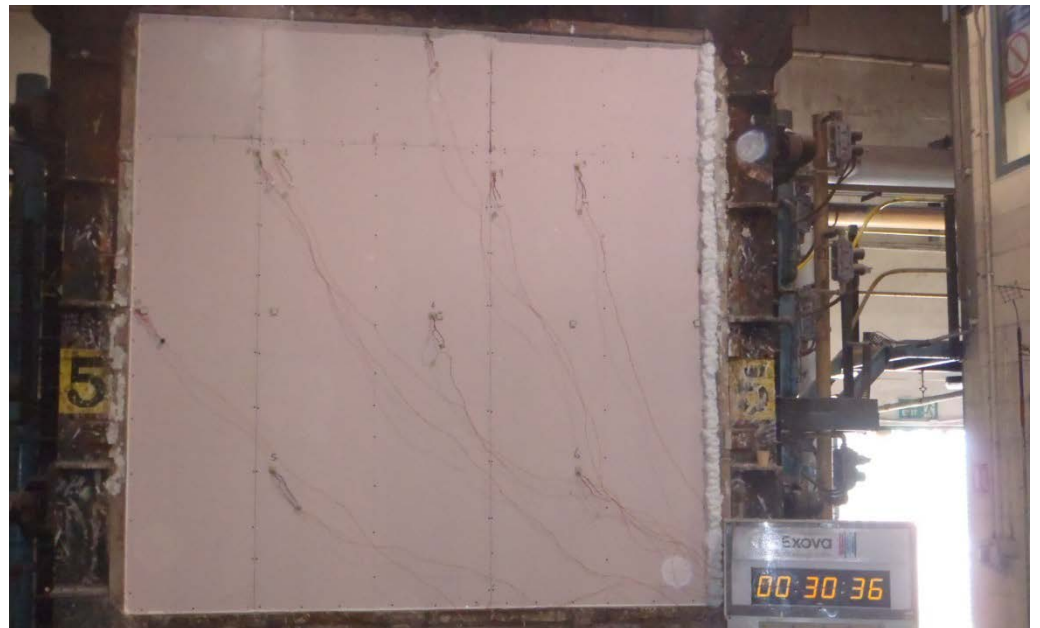
The unexposed face of the test construction after 30 minutes of testing

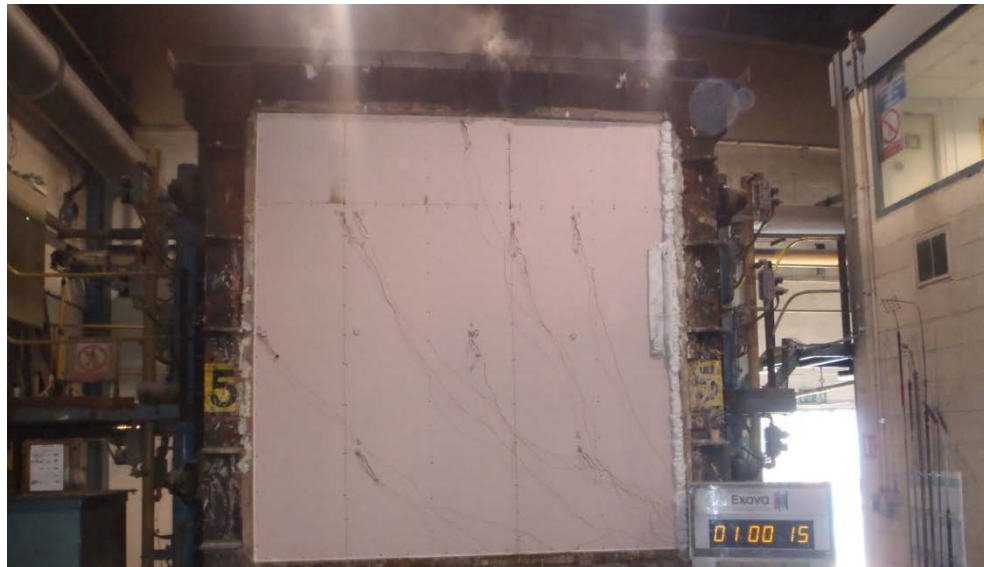
The unexposed face of the test construction after 60 minutes of testing

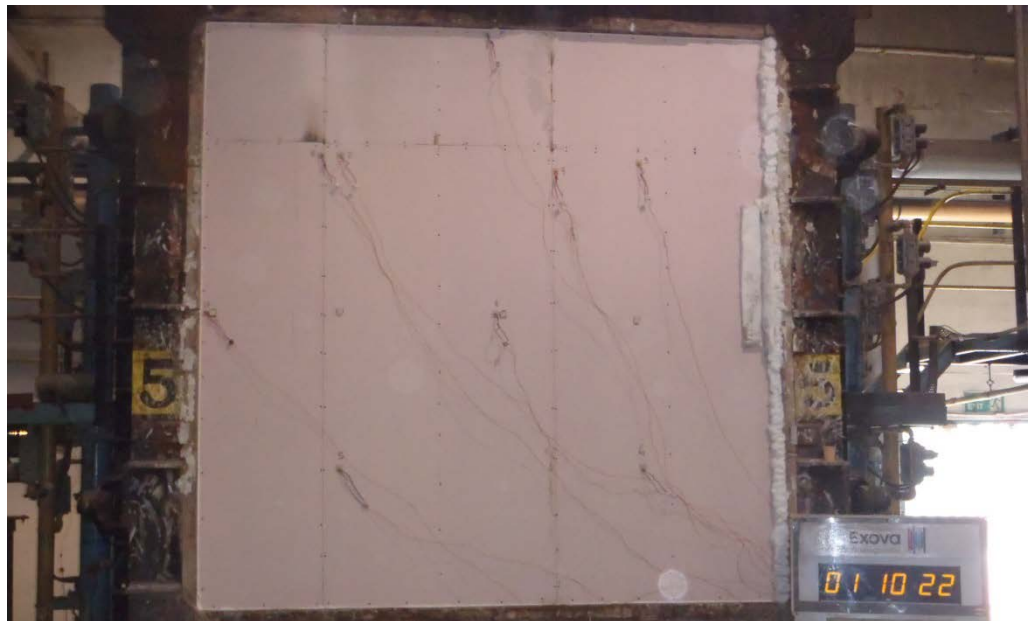
The unexposed face of the test construction after 70 minutes of testing

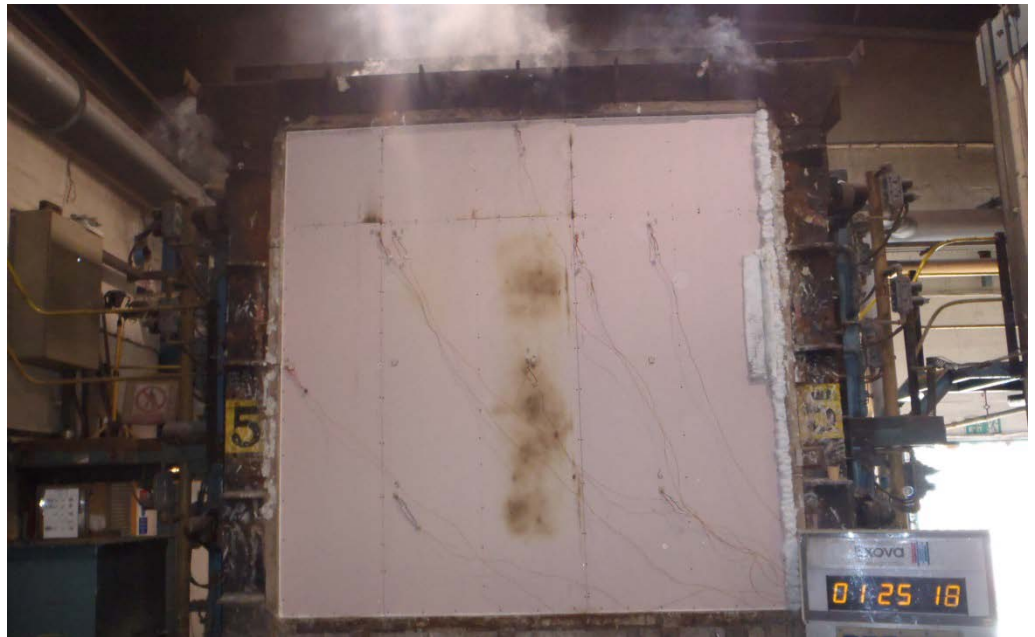
The unexposed face of the test construction after 85 minutes of testing

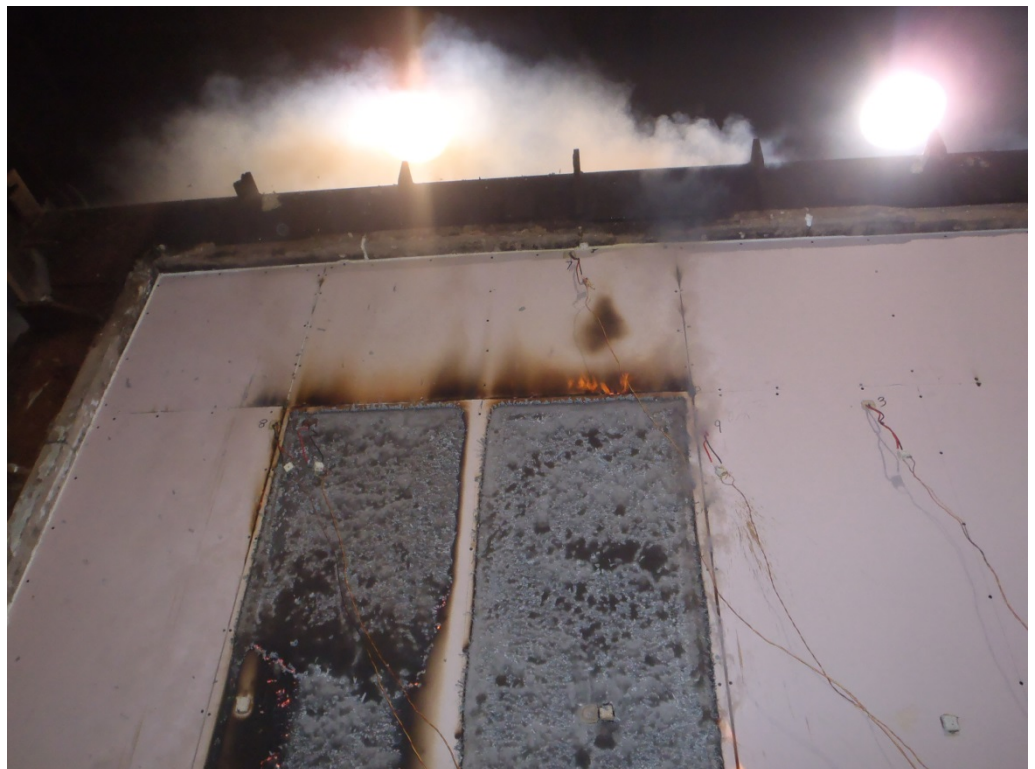
The unexposed face of the test construction after 91 minutes of testing showing the flaming at the joint of the partition.

**Integrity** It is required that there is no collapse of the specimen, no sustained flaming on the unexposed surface and no loss of permeability. These requirements were satisfied for a period of 91 minutes after which time sustained flaming occurred at a horizontal joint position.

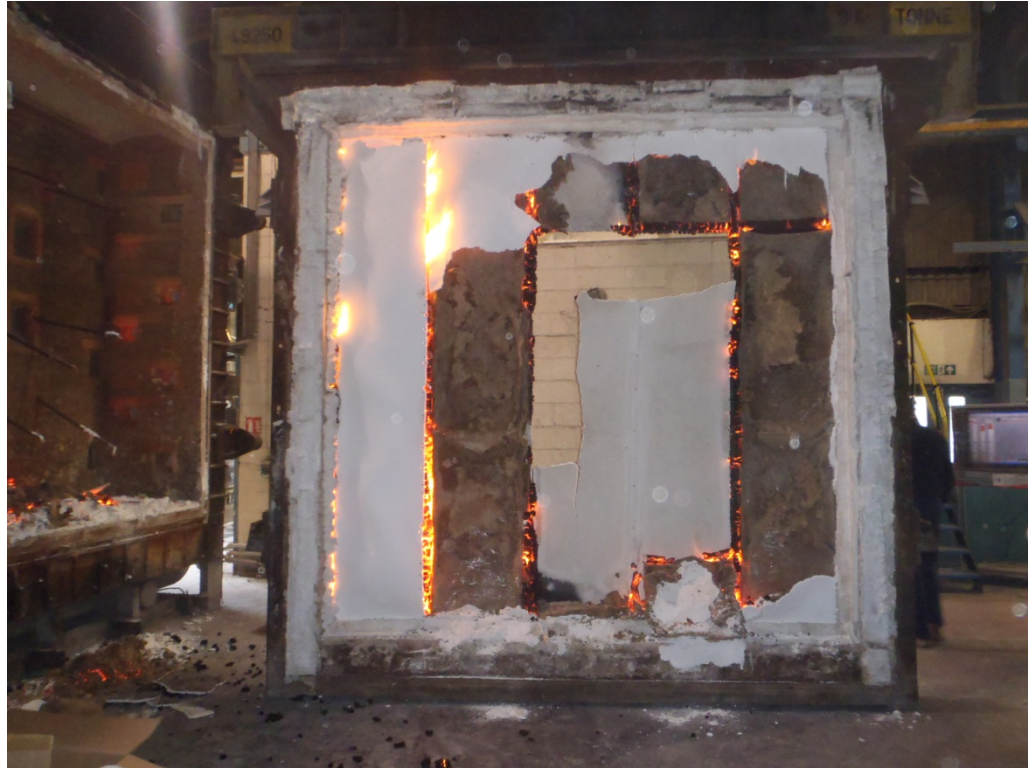
The exposed face  
of the test  
construction  
immediately after  
testing

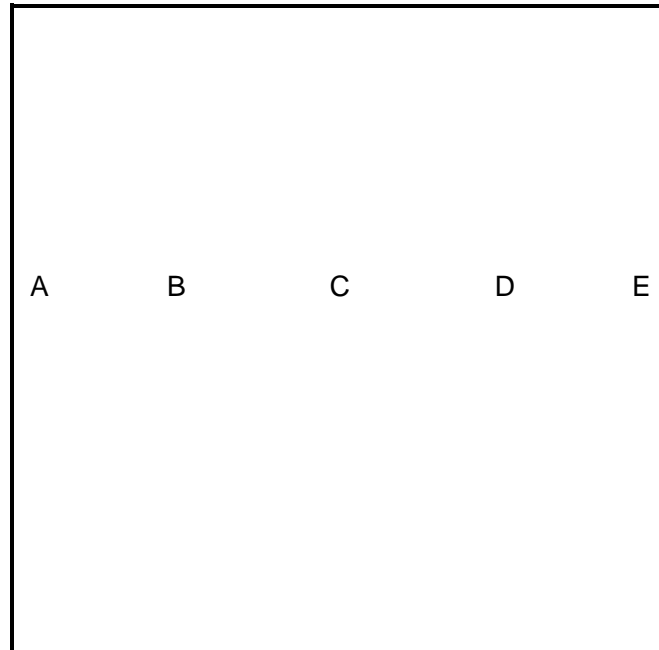
**Deflections of the unexposed face of the specimen during the test**

TIME mins	A	B	C	D	E
0	0	0	0	0	0
10	1	4	3	1	1
20	2	2	-1	-3	0
30	-2	0	-4	0	-3
40	-1	2	-3	-3	*
50	-1	0	-3	-6	*
60	-1	-2	-3	-4	*
70	2	-4	-5	-8	*
80	1	-11	-18	-15	*

All deflections in mm

Note: Positive values indicate deflection towards the furnace chamber

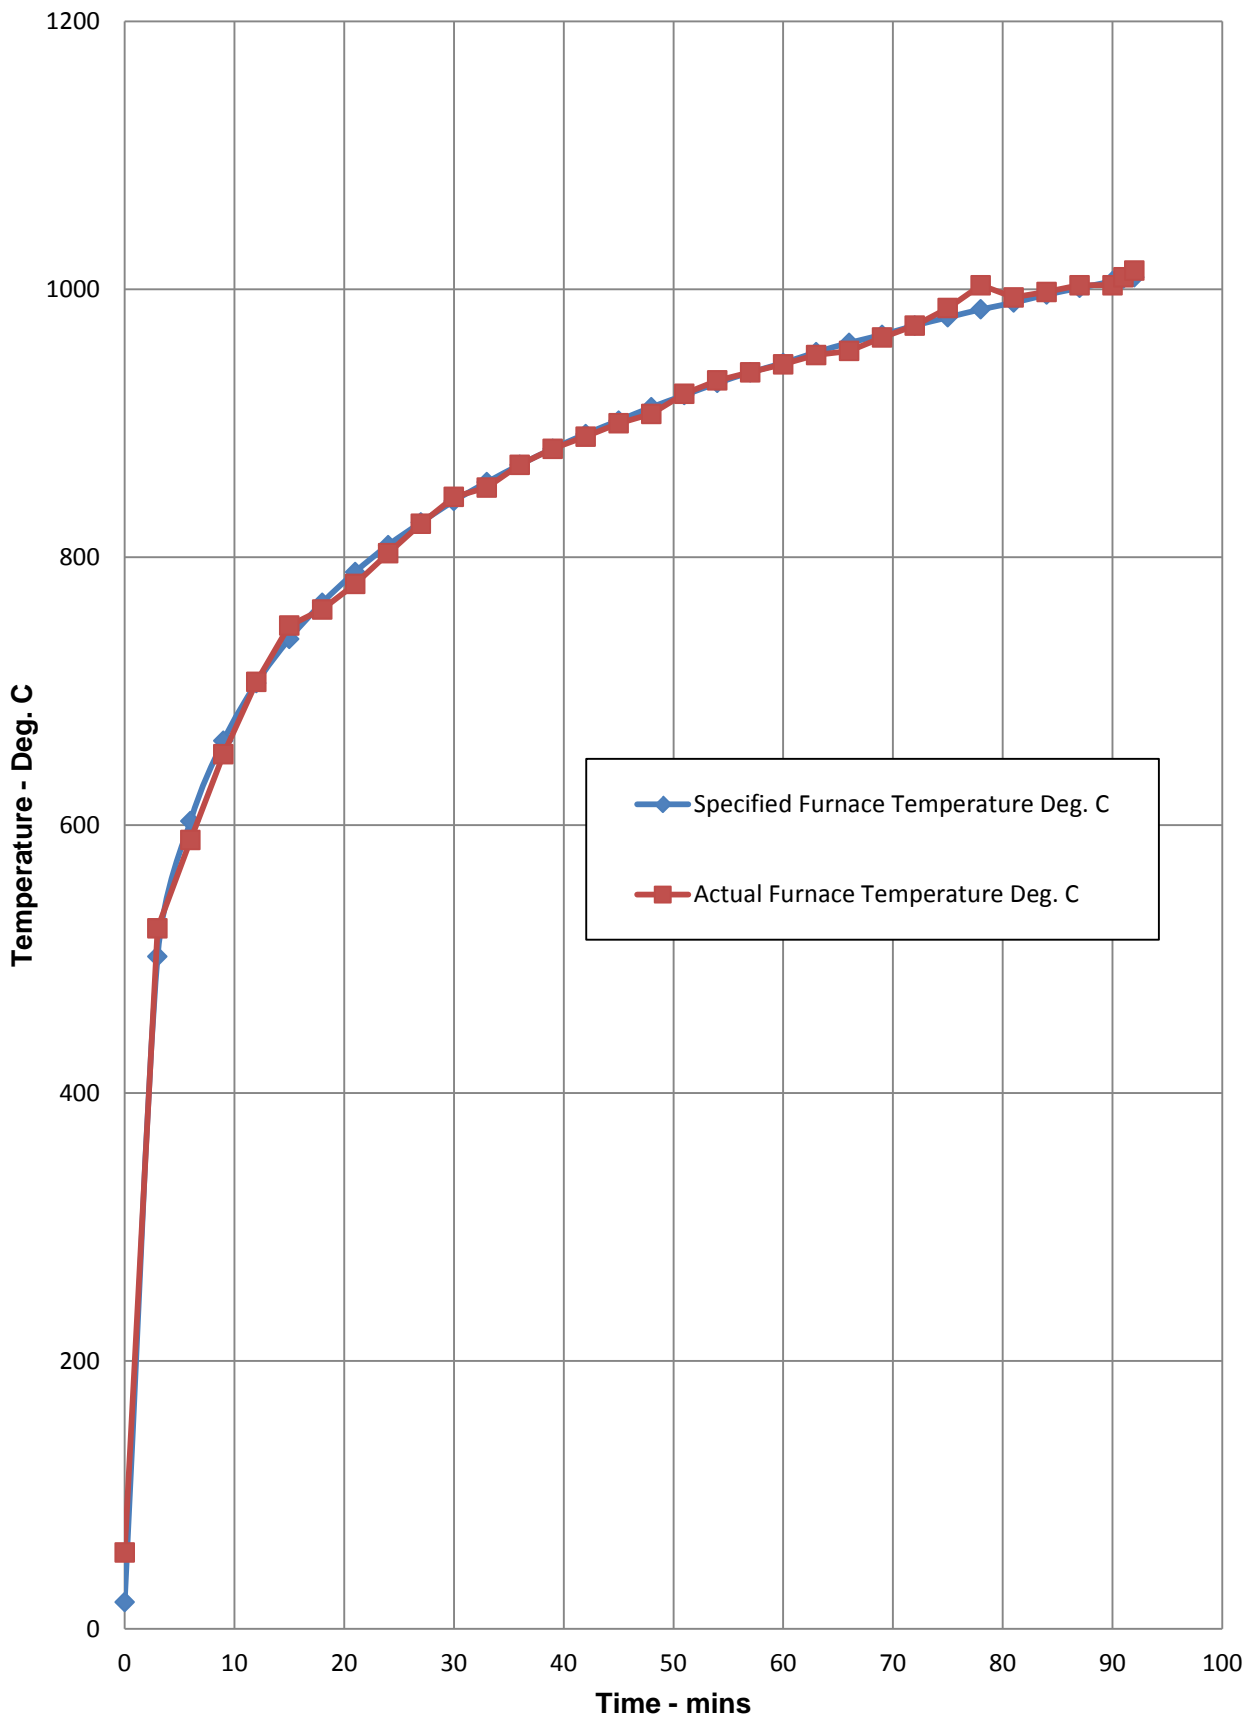
Graph showing mean furnace temperature, together with the temperature/time relationship specified in BS 476: Part 22

Time Mins	Specified Furnace Temperature Deg. C	Actual Furnace Temperature Deg. C
0	20	57
3	502	523
6	603	589
9	663	653
12	706	707
15	739	749
18	766	761
21	789	780
24	809	803
27	826	825
30	842	845
33	856	852
36	869	869
39	881	881
42	892	890
45	902	900
48	912	907
51	921	922
54	930	932
57	938	938
60	945	944
63	953	951
66	960	954
69	966	964
72	973	973
75	979	986
78	985	1003
81	990	994
84	996	998
87	1001	1003
90	1006	1003
91	1008	1009
92	1009	1014
